Warren Residence

Introduction

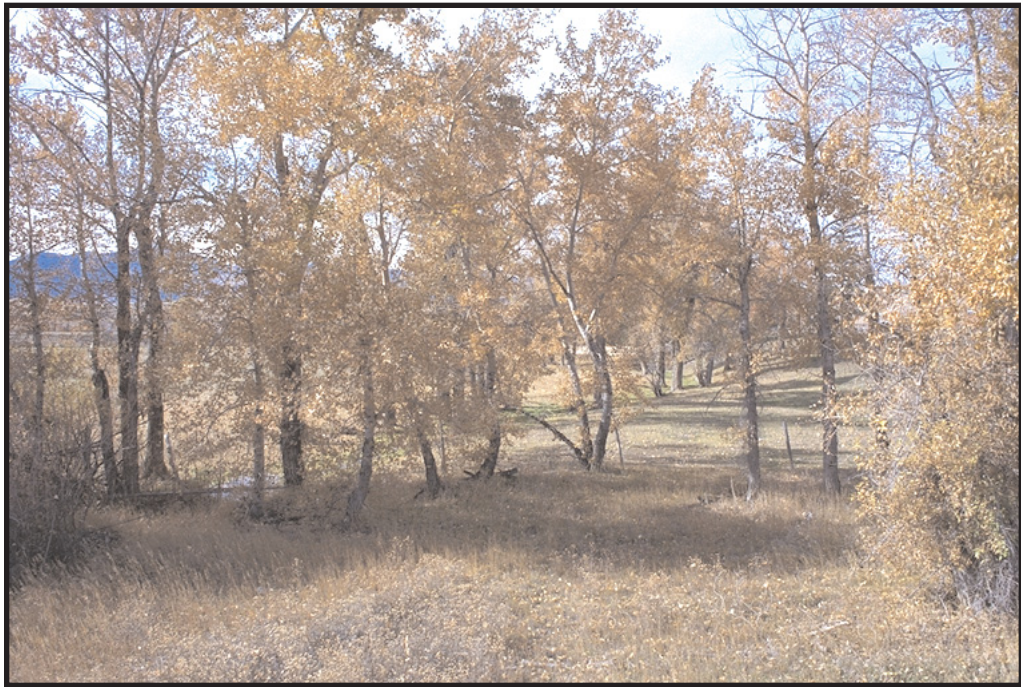
Native, exotic, and ornamental plants occupy the Warren Residence landscape area. Tall native cottonwoods dominate the narrow riparian zone along the Johnson Creek floodplain, (see Photo 3-4-1). A mix of native and exotic grasses is found in the pasture area to the south, while grass is primarily found in the lawn within the domestic yard.

Photo 3-4-1 : (RA-02) Tall native cottonwoods dominate the narrow riparian zone along the Johnson Creek (north fork) floodplain.

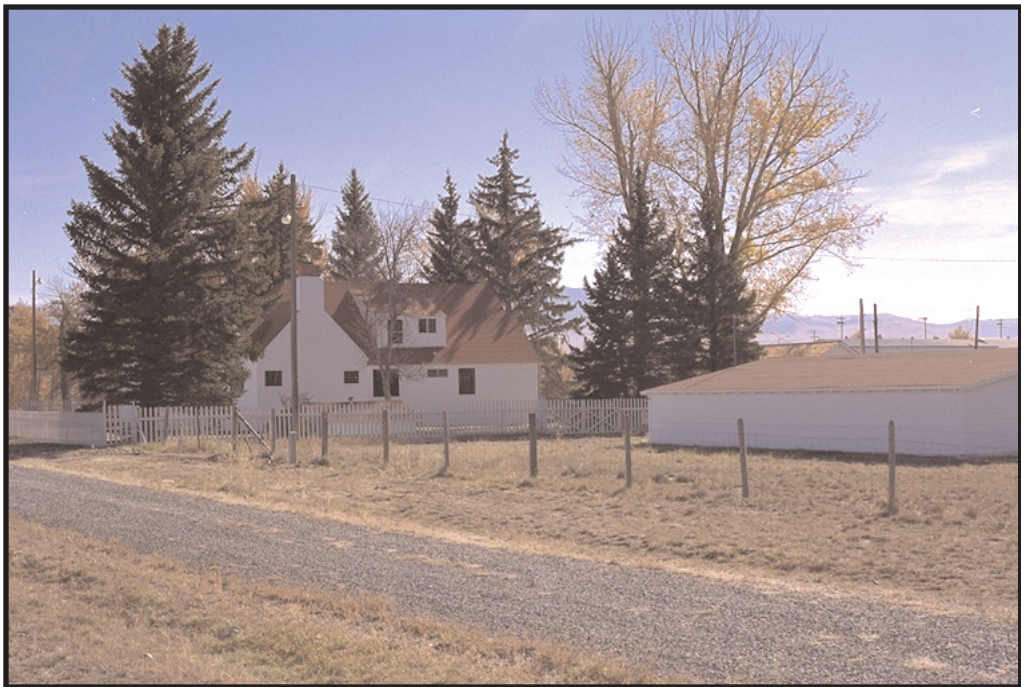
Photo 3-4-2 : (RU-14) Spruce and cottonwood trees dominate the Warren domestic landscape.

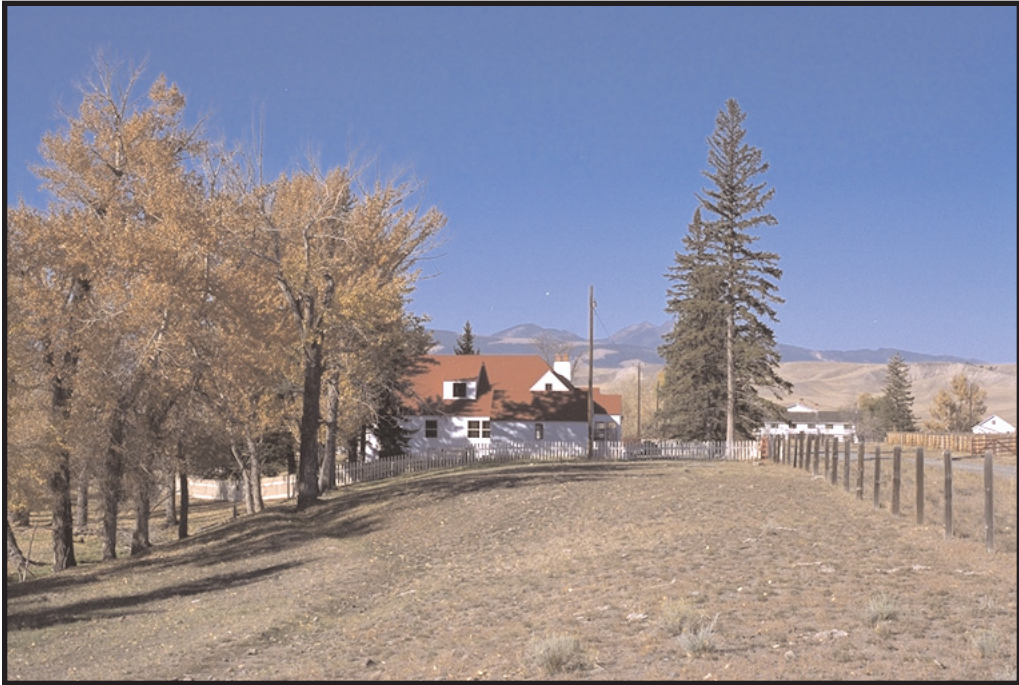
The spaces located within the Warren Residence landscape are defined by the house and its outbuildings, fences, topography, and the large canopy trees. At the larger scale, the landscape contains four fields. The field to the east of the domestic yard is contained by the wood post and sheep wire fence and elevated road bed of Main Street, the entry lane and wood post and wire mesh fence along the north, the Warren domestic yard to the east, and the Johnson Creek riparian corridor to the south (see Photo 3-4-3).

Photo 3-4-3 : (RY-23) East Field.

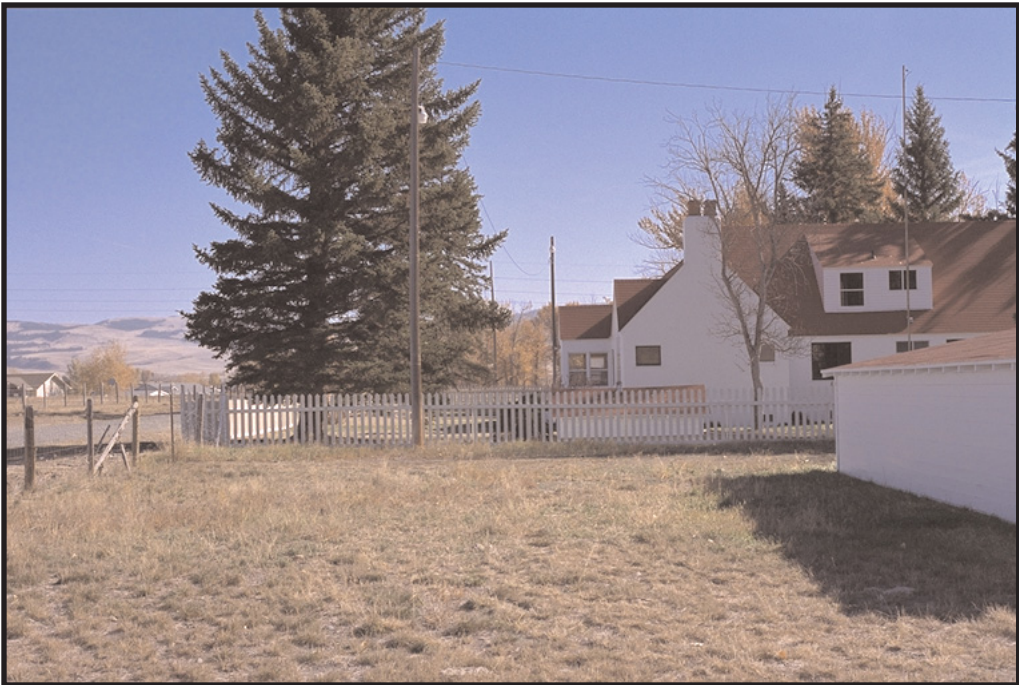
There are two fields to the west of the Warren yard. The first contains the chicken coop and is defined by the entry lane and wood post and sheep wire fence along its north, south, and west sides, and the Warren domestic yard picket fence on the east (see Photo 3-4-4).

Photo 3-4-4 : (RU-08) Chicken Coop Field.

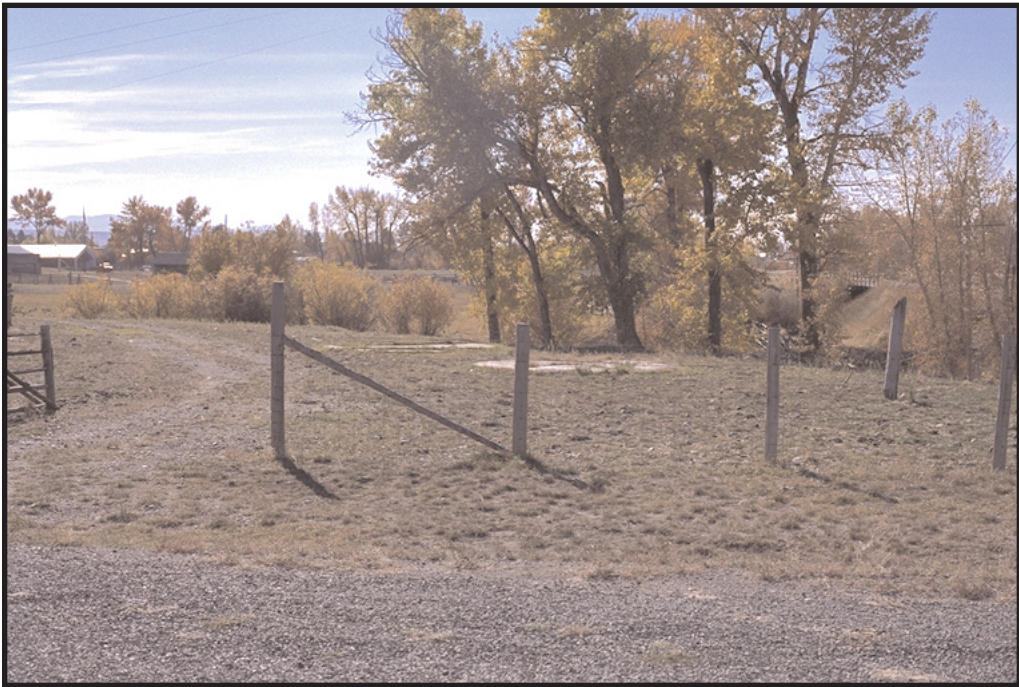
The field to the far west of the house is defined by the entry lane and post and wire fence to the north, the chicken coop field to the east, the jack-leg fence and elevated railroad corridor to the west, and the Johnson Creek riparian corridor to the south (see Photo 3-4-5).

Photo 3-4-5 : (RU-16) West Field.

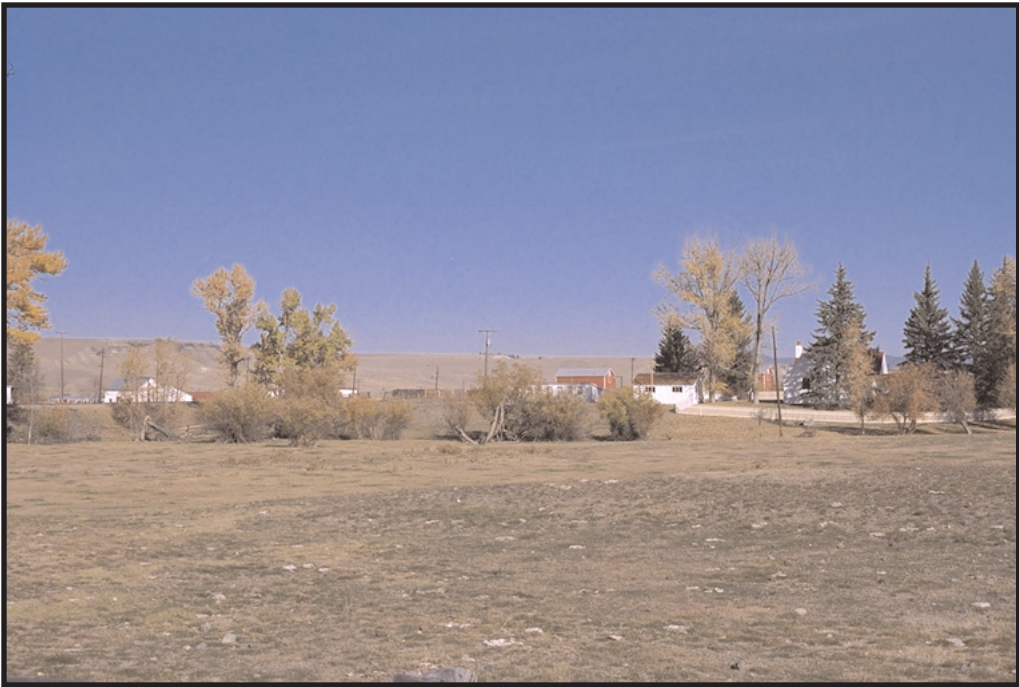
The Stuart Pasture is defined by the Johnson Creek riparian corridor on the north, the fence and drainage swale along Main Street to the east, the jack-leg fence surrounding the Development Zone on the south, and the fence and elevated railroad corridor on the west (see Photo 3-4-6). At times, Warren put late calves here with extra feed.⁴

Photo 3-4-6 : (RZ-01) Stuart Pasture.

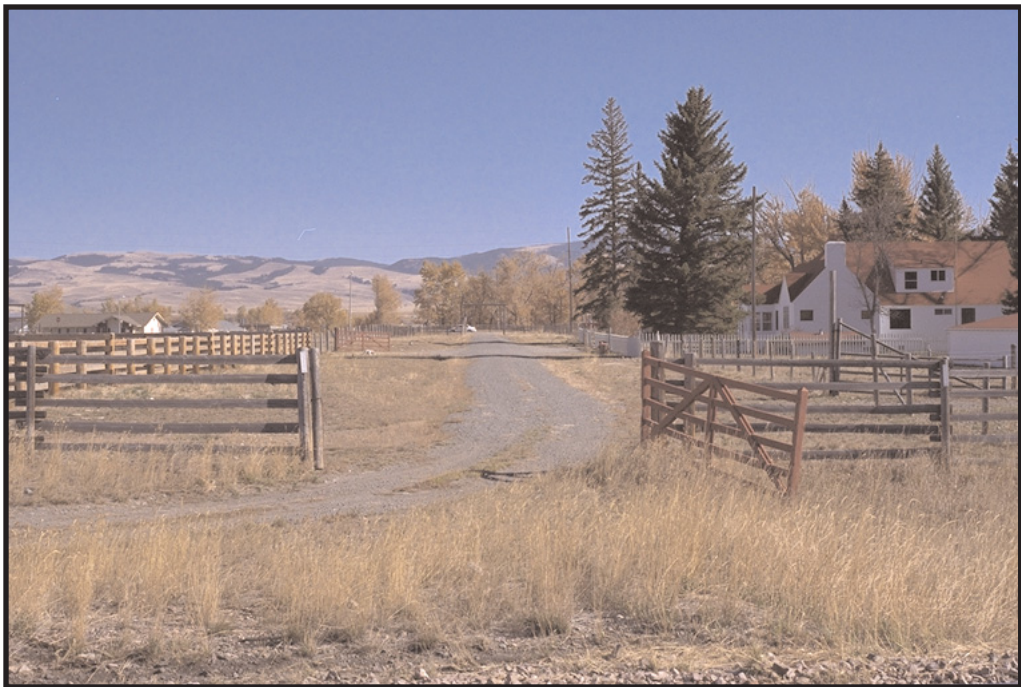
The Warren Residence fronts the historic entry road, Kohrs-Warren Lane, linking the home ranch complex with Main Street (see Photo 3-4-8). Historically this lane was the main entry road to the Grant-Kohrs residence. On axis with the center of the home ranch, this lane was once lined by Cottonwood trees on either side, which were irrigated by a metal pipe. This pipe is still in place.⁶ The Warren residence utilized this same access road; it is still used by the park staff that currently occupies the building.

Photo 3-4-8 : (RU-25) Kohrs-Warren Lane, looking east.

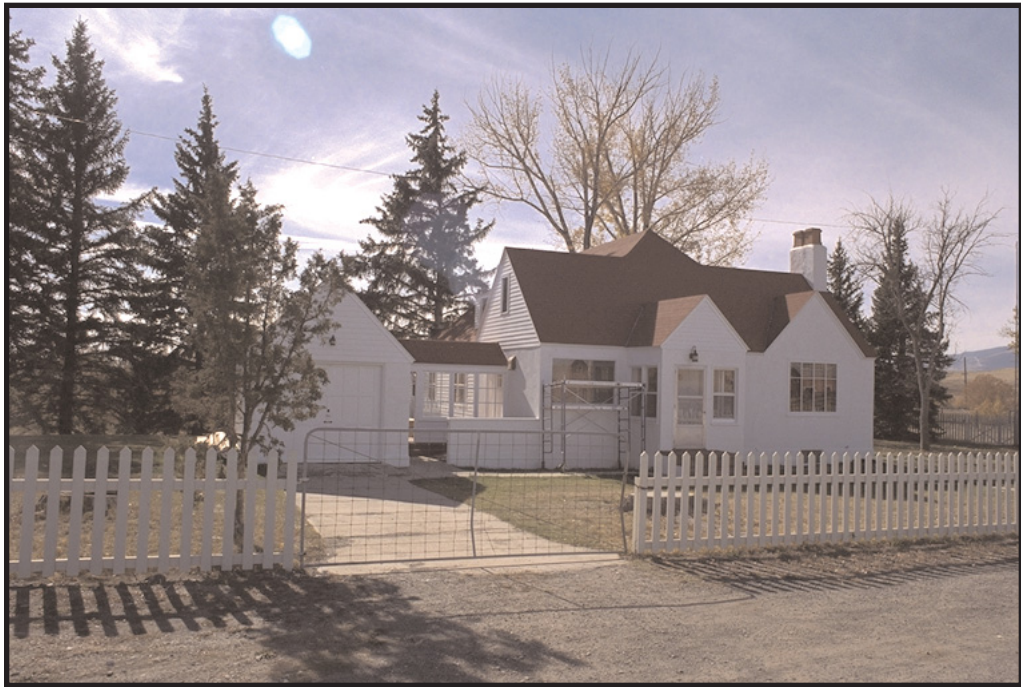
Within the Warren domestic complex, buildings and structures supported and currently interpret the everyday ranch life of Conrad and Nellie Warren. The centerpiece of the complex is the **Warren Residence** (HS-58), (see Photo 3-4-9) built in 1934. The residence is a one-and-a-half story building with an irregular floor plan and a cross gable roof. The wood-frame house sits on a poured concrete footing foundation. White stucco covers the exterior walls on the north and east elevations while horizontal wood siding covers the south and west elevations, dormers, and front gable end. Red and gray asphalt shingles are set in a random pattern over the roof, which was replaced in-kind in 2002. The north side of the house has an enclosed entrance porch. Other north elevation features include one large picture window, one 16-light wood-sash window with four fixed side lights and eight center lights in an operable casement, and one six-light wood-sash casement window.

A nine-light, one panel door is on the south side of the east elevation. Four 16-light wood-sash windows, with operable centers and fixed side lights, are also located on the east elevation. The south elevation interior stucco chimney is topped with terra-cotta chimney pots. The second floor bedroom window has been replaced with a fire exit window.

Photo 3-4-9 : (COMP-32) Warren Residence (HS-58).

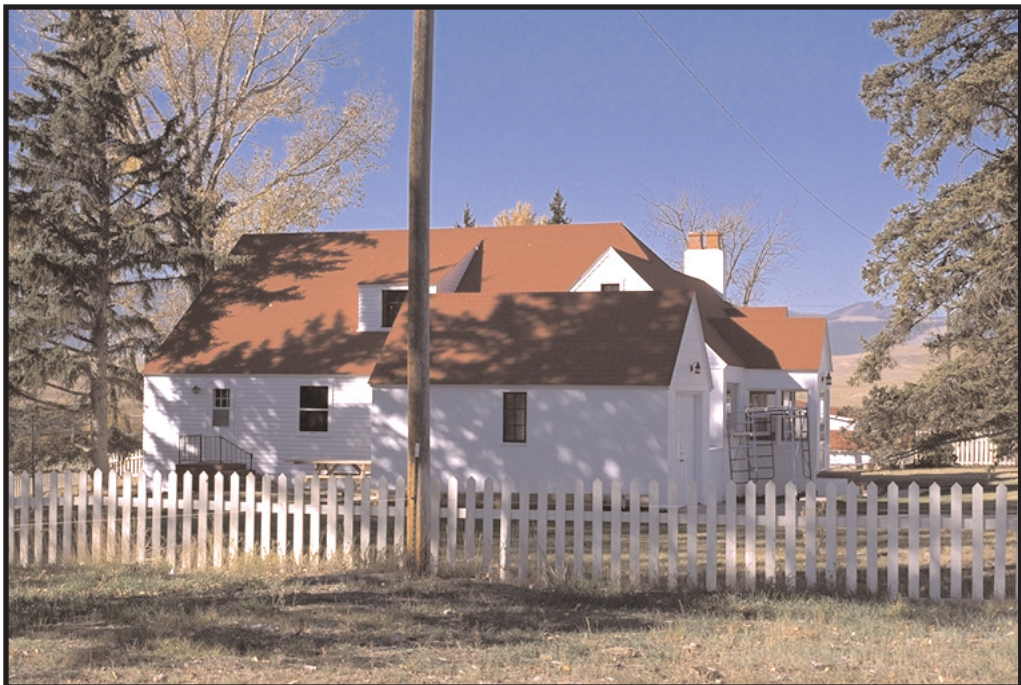
The **Garage** (HS-61), (see Photo 3-4-10) is attached to the western elevation of the house by a wood-frame breezeway. The breezeway features horizontal beveled wood siding and three fixed-sash, wood-frame windows. The breezeway is original to the 1934 construction; it was not enclosed until the 1980s. The garage is a one-story, rectangular, wood-frame building constructed on a concrete pad. Gray and red asphalt shingles cover the gable roof. White stucco covers the exterior walls and the gable ends are covered with horizontal beveled wood siding. A wooden, 18-panel, overhead door dominates the north elevation. A centered, one-panel door provides access from the breezeway on the west elevation. Both the south and east elevations contain a centered, six-light, steel casement window.

Photo 3-4-10 : (RY-10) Warren Garage (HS-61).

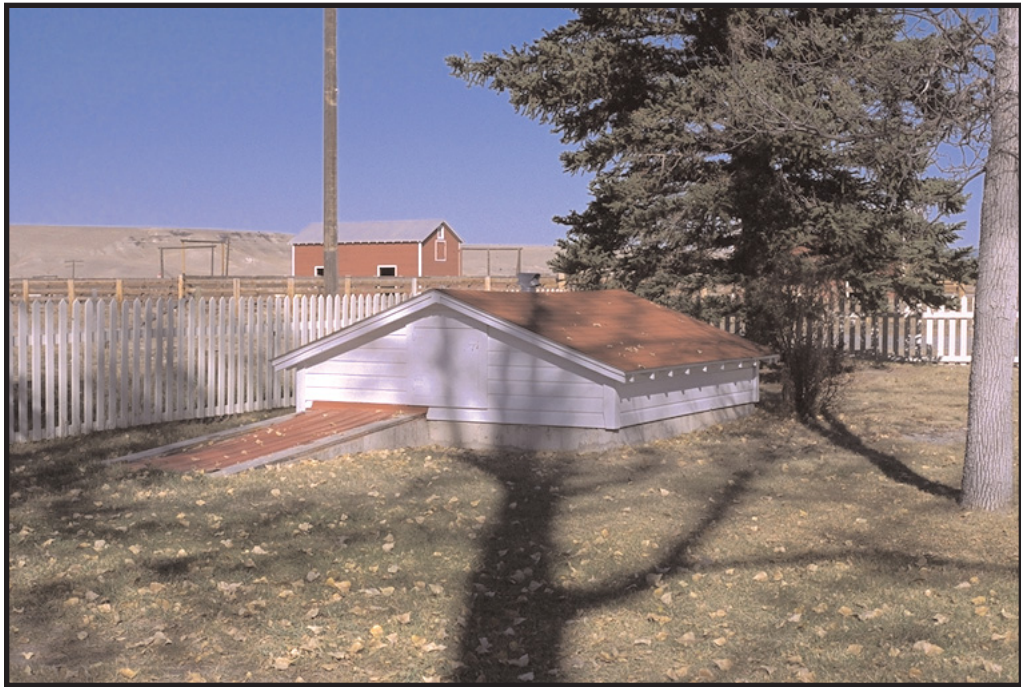
The **Warren Residence Pump House** (HS-88), (see Photo 3-4-11) was built in 1952 and lies west of the Warren residence. The pump house is a rectangular, half-buried concrete structure with a gabled roof. The structure is exposed to a height of three feet above the ground. The walls are poured-in-place concrete. A hatch door on the south side of the building provides access to the interior. The roof has red asphalt shingles and exposed rafter ends. Five-inch dropped wood siding and 4-inch wood corner trim fill the gable ends. NPS installed a new pump and pressure tank during the 1990s.

Photo 3-4-11 : (RV-23) Warren Residence Pump House (HS-88).

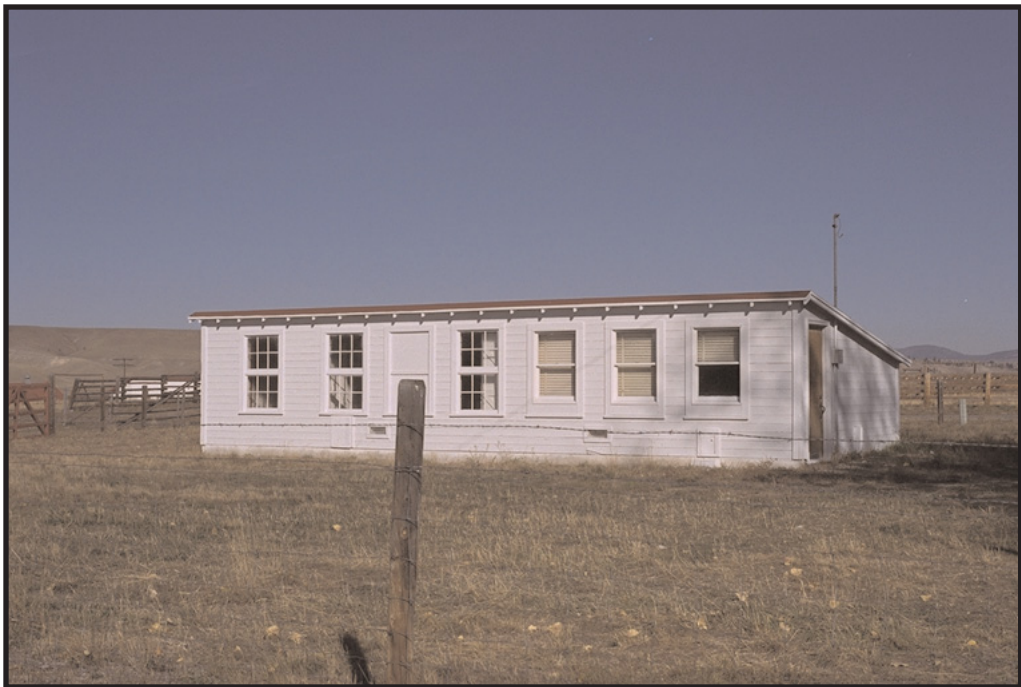
Built in 1940, the **Chicken Coop** (HS-59), (see Photo 3-4-12) is a one-story, rectangular, wood-frame building set on a concrete pad and located west of the Warren residence. Red mineral rolled asphalt roofing covers the shed roof and rafter ends are exposed on the north and south elevations. Horizontal wood siding covers the exterior walls. Doors are located on the eastern and western elevations. The south elevation contains seven windows. Two rectangular vents and two chicken doors are located low on the south elevation.

Photo 3-4-12 : (RZ -21) Chicken Coop (HS-59).

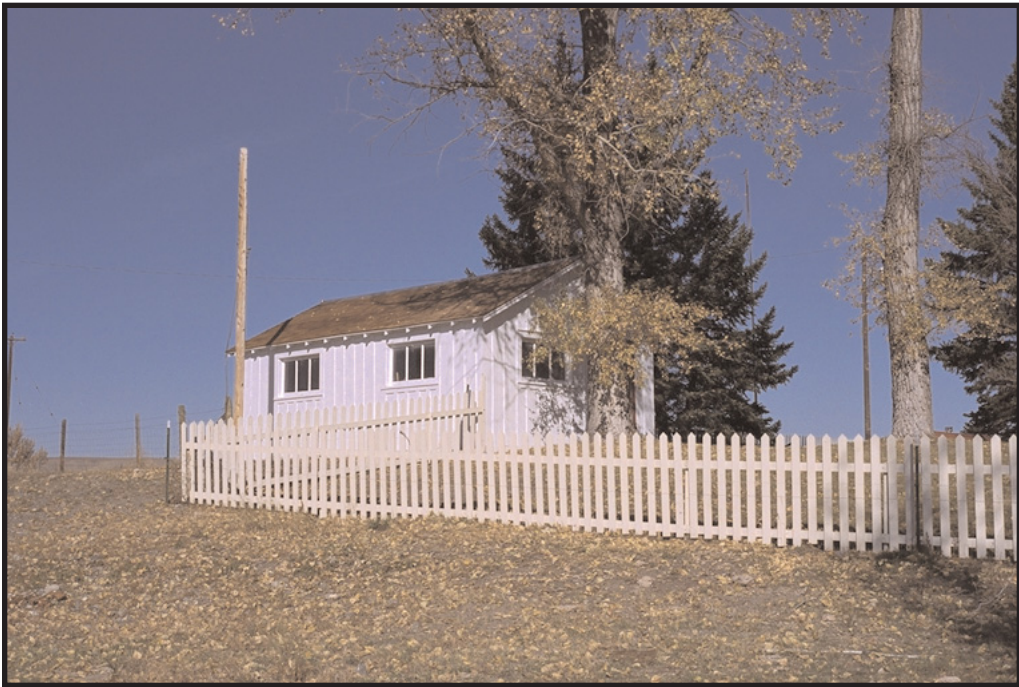
The **Boat House** (HS-60), (see Photo 3-4-13) was constructed in the 1950s as storage for Conrad Warren's sailboat. The boat house is a one-story, rectangular, wood-frame building constructed on a concrete pad. Vertical board-and-batten siding covers the exterior walls. The gabled roof is covered with wood shingles. A four-panel wood door is located on the east elevation. Windows are three-light, wood-frame hoppers. A side-hinged, board-and-batten double garage door dominates the west elevation.

Photo 3-4-13 : (RZ-24) Boat House (HS-60).

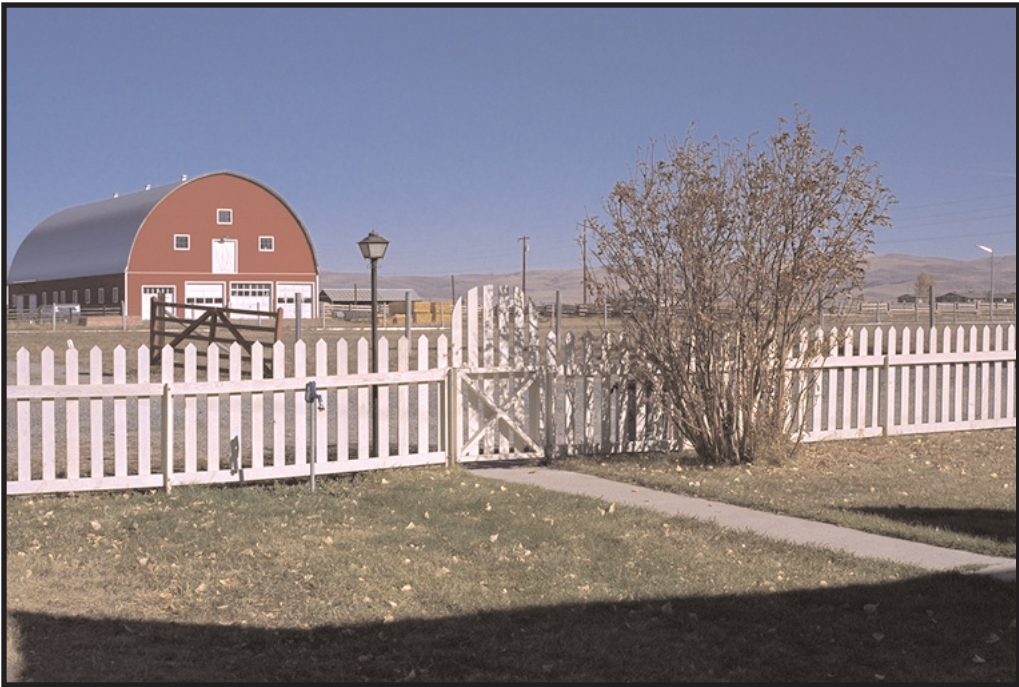
The most prominent fence type of the component landscape is the **Picket Fence** that surrounds the Warren Residence (see Photo 3-4-14). The fence consists of white-painted, vertical, wooden pickets attached at the top and bottom to horizontal supports. All wood members were replaced in-kind ca. 2001.⁷ The fence surrounds the Warren residence on all sides.

The picket single gate is located on the north edge of the Warren residence; at the end of a concrete sidewalk leading from the house to the road. The gate is between 3 and 4 feet wide and consists of a square, cross-braced frame. The pickets that cover the frame are taller than the regular pickets and cut to form a rounded top.

Photo 3-4-14 : (RV-02) Picket Fence and Picket Single Gate.

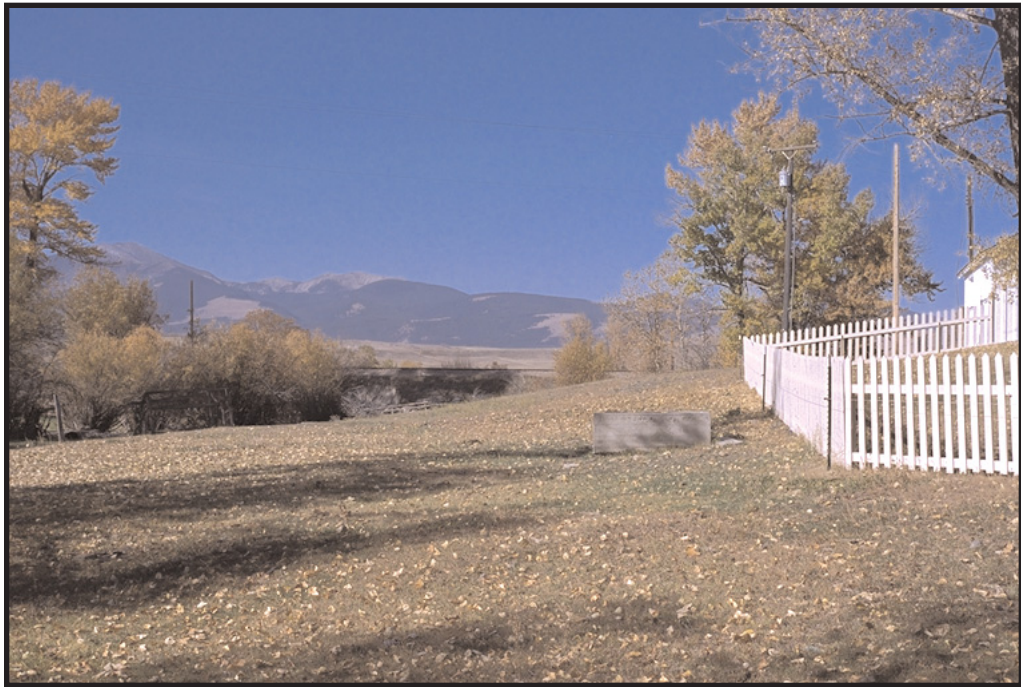
An **Electrical Fence** runs adjacent to the eastern and southern sections, and on the pasture side, of the picket fence (see Photo 3-4-15). This fence consists of short, metal posts supporting a single metal wire that carries some level of voltage. Installed by the NPS, this fence prevents cattle from leaning against, and thus damaging, the picket fence.

Photo 3-4-15 : (RU-05) Electrical fence along outside of picket fence.

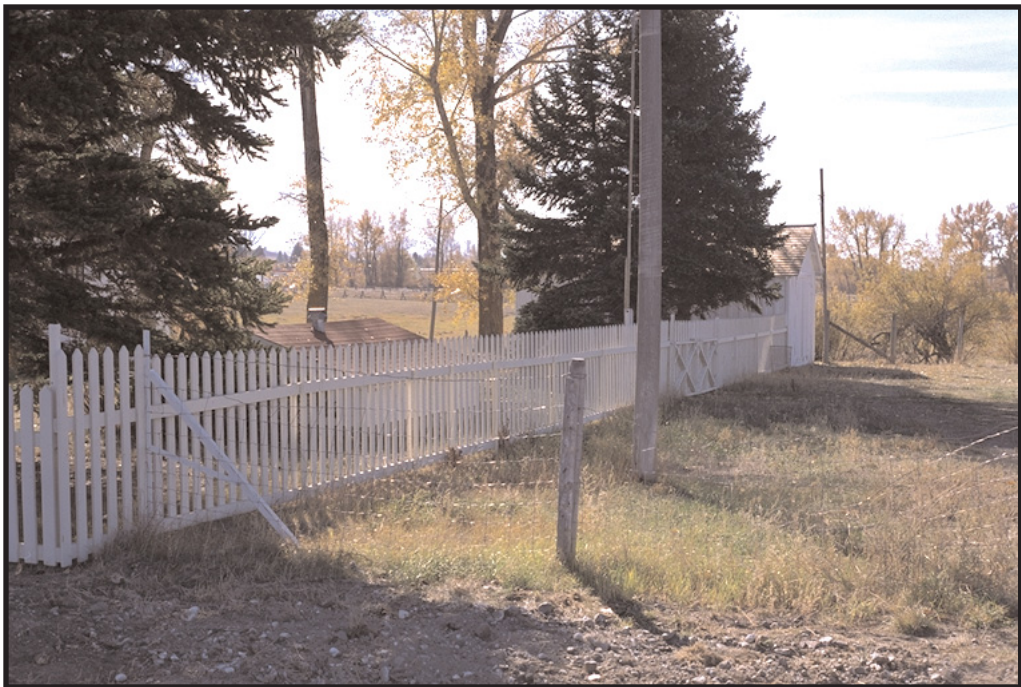
Three types of gates are associated with the picket fence: the **Picket Double Gate**, (see Photo 3-4-16) **Picket Single Gate**, (see Photo 3-4-14) and **Wire Mesh Gate**, (see Photo 3-4-17). The double gate is located on the western side of the Warren residence. The wood gate consists of two rectangular frames that swing open at the center. The frames, cross-braced on the interior and attached to hinge-posts at opposite ends, are covered with evenly-spaced white pickets, matching those found on the regular fence.

The small corral surrounding the chicken coop and the larger corral delineating the Warren residence limits are both defined by **Wood Post and Woven Wire Fence**, (see Photo 3-4-16). This fence is typical of other wood and woven wire fences found within the CLR study boundary. Woven Wire fence consists of un-milled wood posts or peeled logs supporting a wire mesh component. Variations of this fence type include metal posts or a combination of wood and metal posts supporting wire mesh. Sheep Wire fence is commonly referred to as woven wire fence. This fence type is also found in this landscape, and is common throughout the ranch. It is bundled in a large roll and, when stretched, it has a strong wire top and bottom. Wire squares are larger on top and smaller on the bottom.

Photo 3-4-16 : (RX-21) Picket fence and Picket Double Gate. Woven Wire Fence in foreground. Note antenna pole near picket double gate.

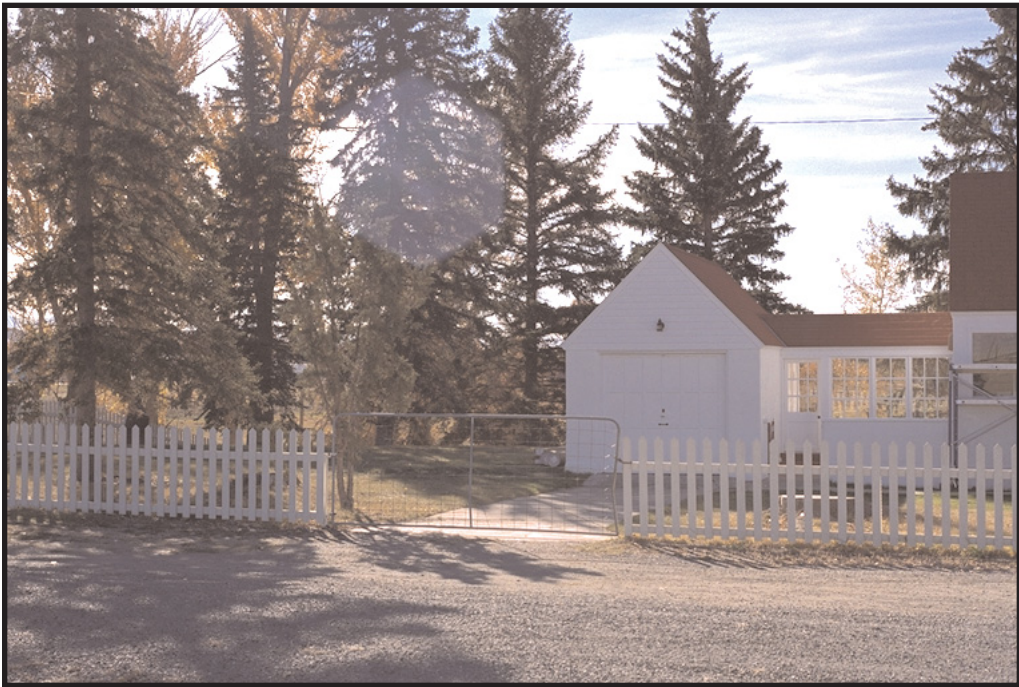
The wire mesh gate is also located on the north edge of the Warren residence and encloses the driveway leading to the Warren Garage. The rectangular, metal pipe frame gate is between 12 and 15 feet wide. Wire mesh fills the pipe frame while a diagonal wire brace reaches from the hinge-post to the opposite, lower corner for support.

Photo 3-4-17 : (RX-08) Wire Mesh Gate.

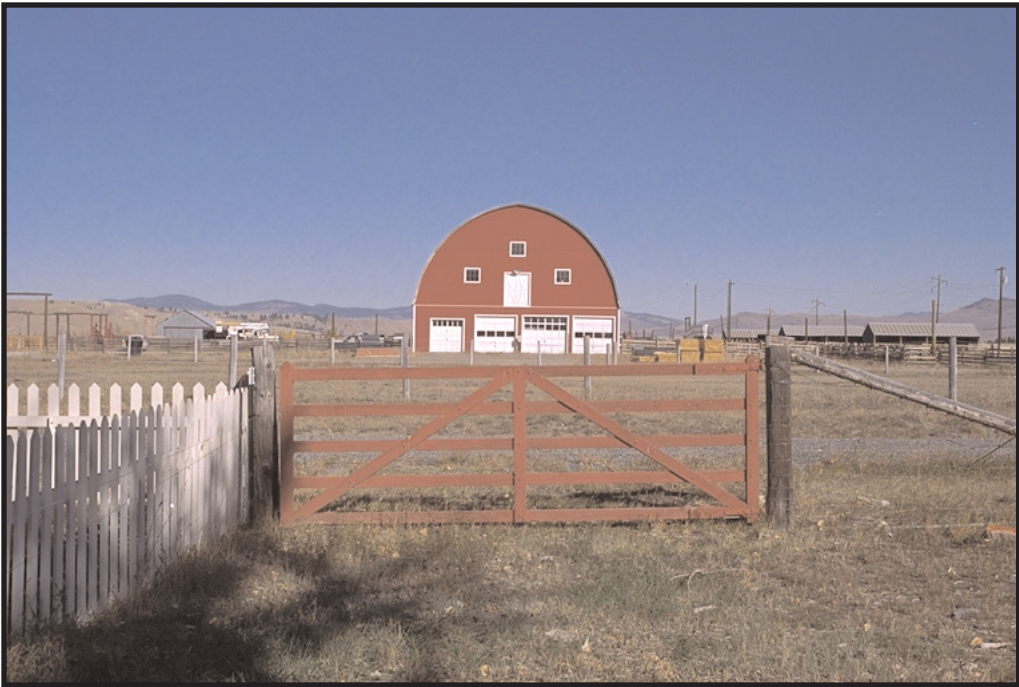
Associated with this fence type is the **Red Wood Gate**, (see Photo 3-4-18) typical of other red gates found within the study boundary. Located on the western edge of the chicken coop corral, this red-painted gate consists of five milled boards attached horizontally to support posts at either end. The gate is braced on each side with a central vertical board and two diagonal boards.

Photo 3-4-18 : (RY-16) Red Wood Gate.

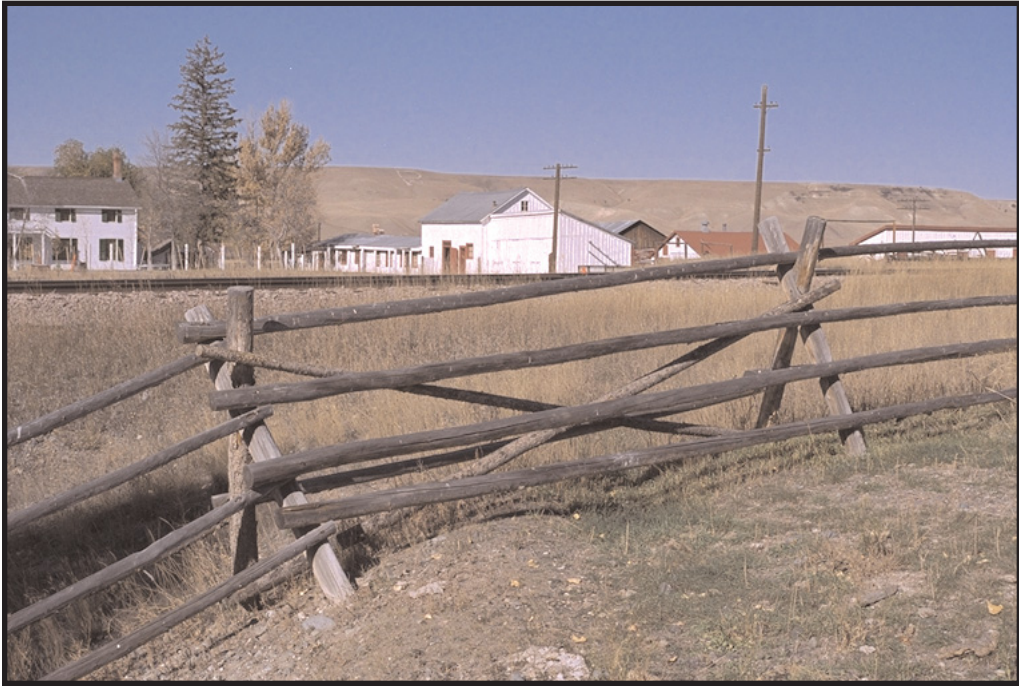
Rather than wood post and woven wire fence, **Jack-Leg fence**, (see Photo 3-4-19) is located along the western edge of the Warren Residence landscape. The Jack-Leg fence consists of two posts that are crossed at the top to form X-shapes. These "X-posts" support 4 horizontal rails; the top rail rests in the crux of the X while the remaining three are attached to one of the posts that create the X. A fifth rail is attached to the opposite side of the fence, near the bottom. This arrangement creates an angled, rather than upright fence.

Photo 3-4-19 : (RU-22) Jack-Leg Fence.

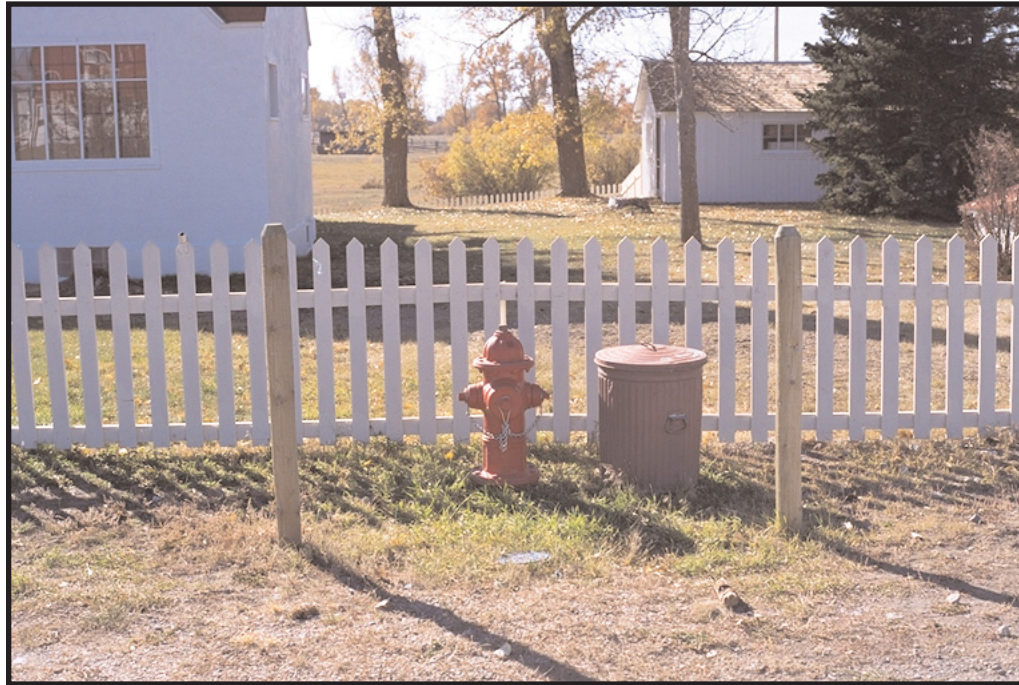
Several other small scale features are located within the Warren Residence component landscape. These include a **fire hydrant** and an **NPS mailbox** located along Warren Lane, directly to the north of the residence (see Photo 3-4-20), as well as a metal garbage can containing a fire hose with two wooden posts on either side. The mailbox post-dates this photo. To the east of the residence, along the inside of the picket fence, is an approximate four foot by four foot square **concrete foundation** that once supported the barbeque stove. A **metal burn barrel** now rests on this foundation (see Photo 3-4-21).

Photo 3-4-20 : (RX-17) Fire hydrant.

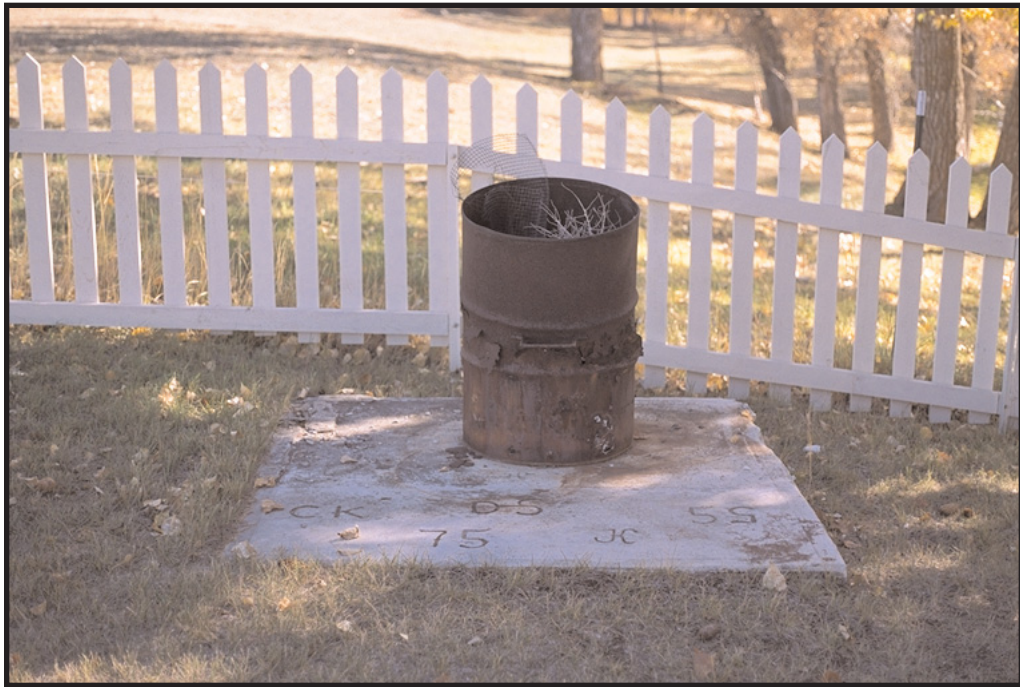
Photo 3-4-21 : (RV-10) Concrete foundation and metal burn barrel. Note that the family brands are still visible (the "CK" is Conrad Kohrs; the large "K" is a horse brand; "D-S" is Davis Hanson Stuart; and the right-side-up and upside-down pair of fives is Five Up and Five Down).

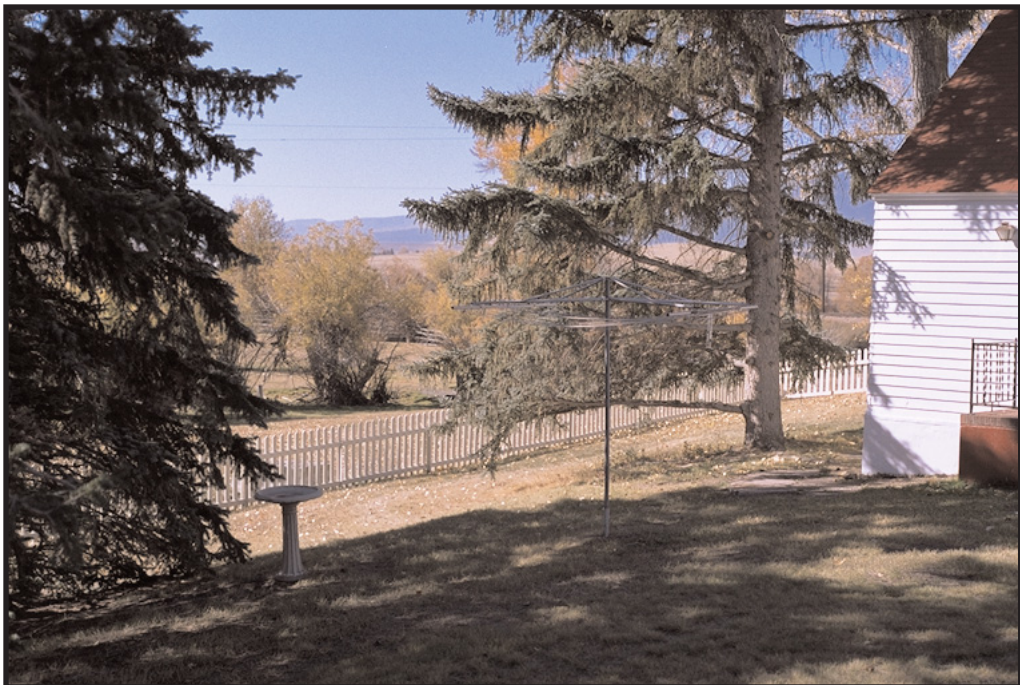
A freestanding **clothes line** structure is located just off the southeast corner of the residence. This is a four-sided metal pipe structure and has been painted dark green. A **concrete bird bath** is located just to the east of the clothes line (see Photo 3-4-22).

Photo 3-4-22 : (RV-11) Clothes line and concrete bird bath.

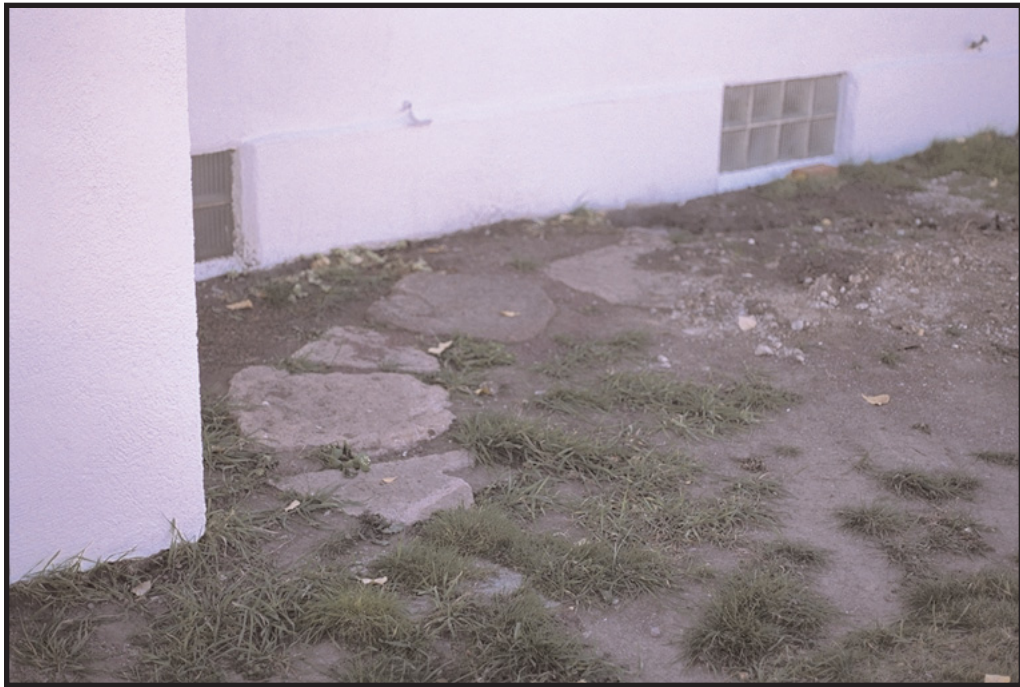
Along the north side of the residence, several stepping stones are located within the foundational planting area (see Photo 3-4-23). Found just to the west of the entry porch, these stones are not in their original configuration. Originally they curved from the front door to the front gate, and were subsequently covered/replaced by the covered porch and concrete path.⁸

Photo 3-4-23 : (RV-3) Stepping stones along front of house. This is not the original configuration. When the NPS dug up the vegetation and repaired the drainage, they did not replace the stones in their exact locations and did not photo-document the change. They curved from the front door to the front gate, and were covered/replaced by the covered porch and concrete path.

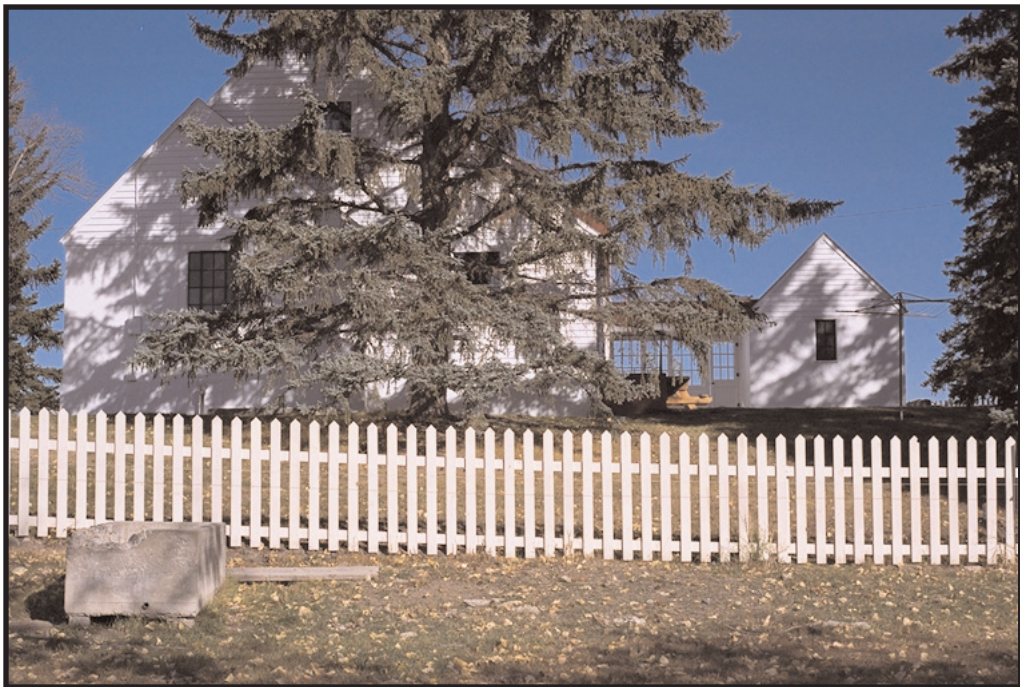
An approximate three foot by three foot square **concrete trough** is located to the rear of the domestic yard (see Photo 3-4-24). This structure is supported by concrete feet. A **magpie trap** is located further to the south and west, near the north fork of Johnson Creek (see Photo 3-4-7). This is a wooden frame structure constructed of wooden posts, with a concave wood frame top supporting chicken wire mesh. This structure measures approximately five feet by five feet, and the mesh rests approximately three feet off the ground. This structure will likely be removed by the NPS.

Photo 3-4-24 : (RY-2) Concrete Trough.

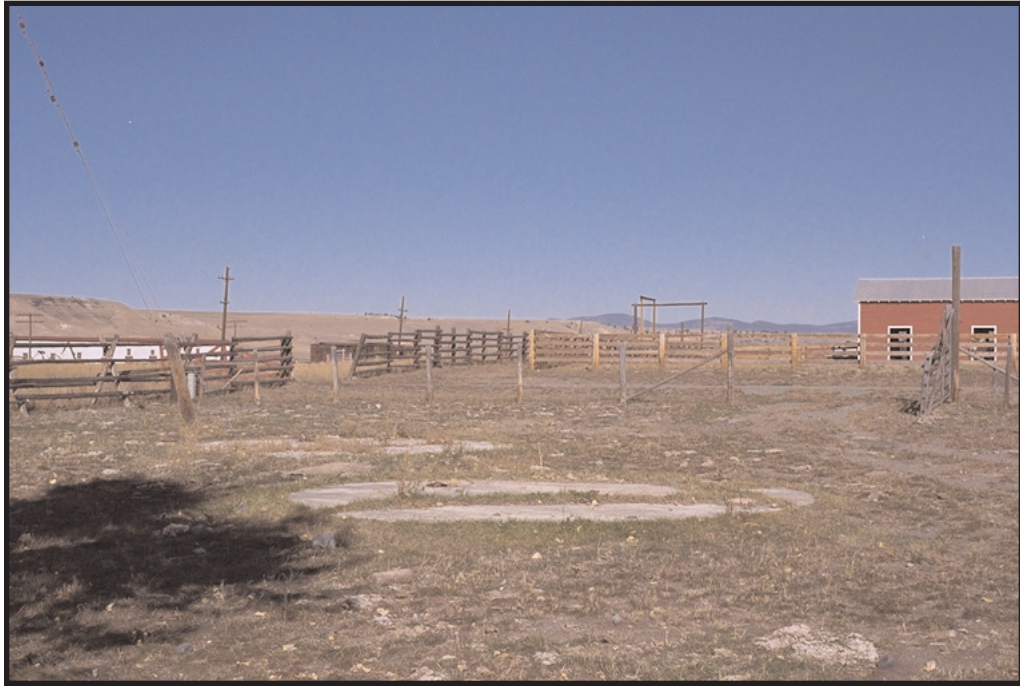
Based upon analysis of an aerial photograph dating from 1960, two granary foundations are located west of the Warren Chicken Coop (HS-59), west of the road leading south to the Warren pasture. While the granaries are no longer extant, their concrete foundations remain (see Photo 3-4-25). Based upon photographic evidence and staff recollections, these features were removed between 1954 and 1974.

Photo 3-4-25 : (RU-23) Remnant concrete granary foundations.
